Tree Amenity Valuation /Inspection Report

Avendon Boulevard Footpath Works

Glen Waverley

Date:17/4/23

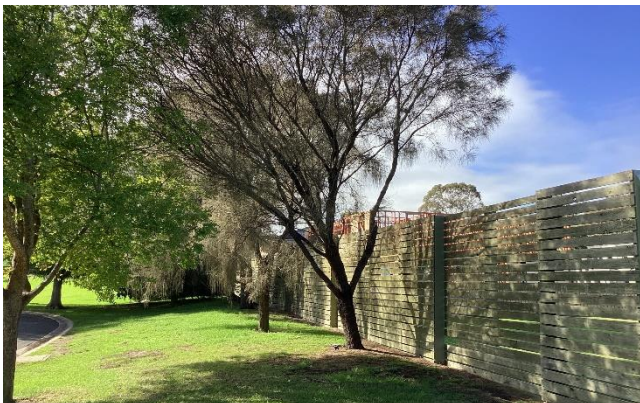
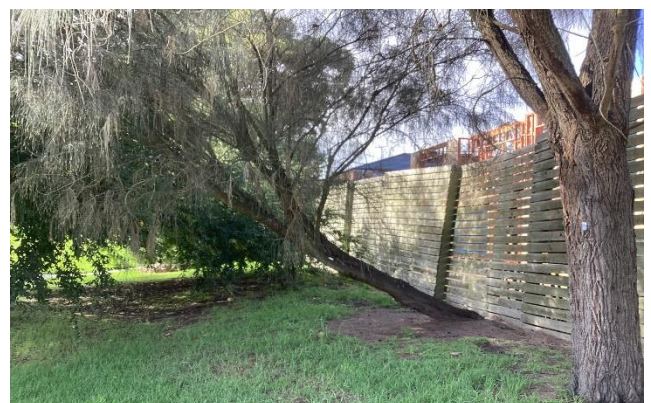
Tree #1 - 4 *Allocasuarina verticillata* – Drooping she-oak

Tree #1 - 4: *Allocasuarina verticillata* – Tree #1 has an acute lean with heaving at the root plate. The health and stability of all four trees will be compromised by the level of incursion into the TPZ and SRZ. Recommended for removal.

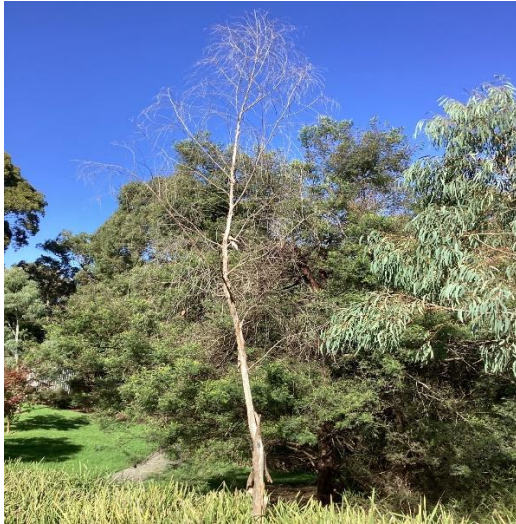
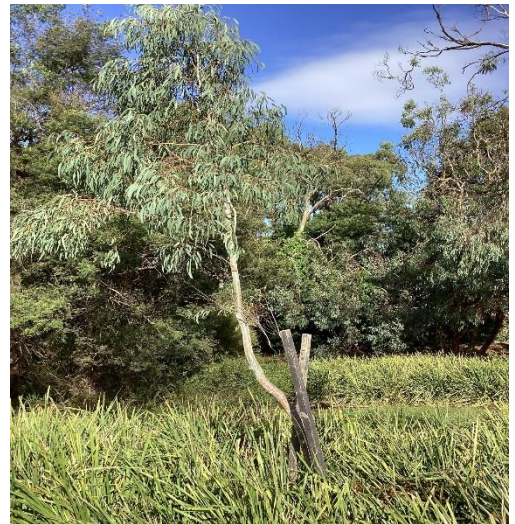
Tree #5 - 7 *Eucalyptus scoparia* – Wallangarra white gum

Tree #5 : *Eucalyptus scoparia* – Tree is dead. Removal required.

Tree #6&7: *Eucalyptus scoparia* – Poor structure and movement in the root plate. Removal required.

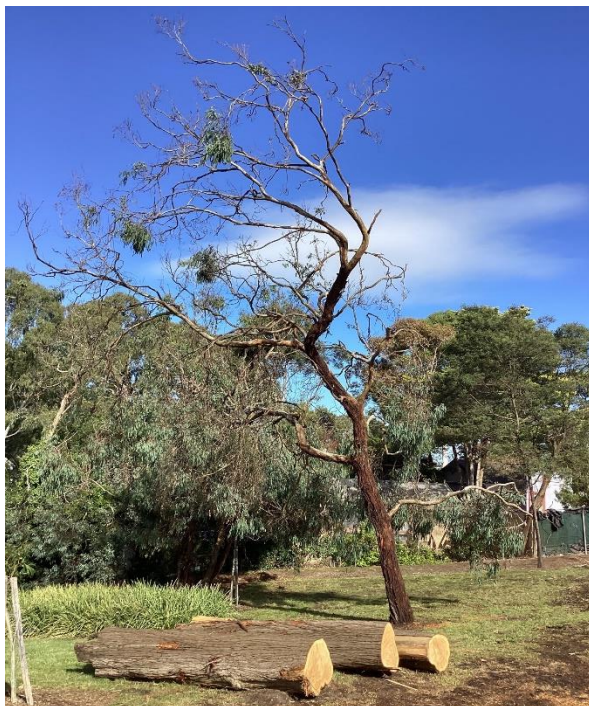
Tree #8 *Eucalyptus cephalocarpa* – mealy stringybark

Tree #8: *Eucalyptus cephalocarpa* – Tree is in severe decline with a large amount of deadwood present. Removal required.

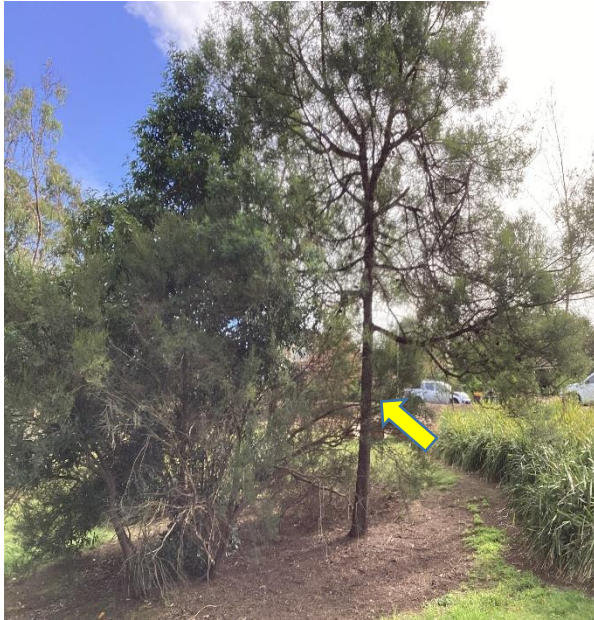
Tree #9 *Acacia dealbata* – silver wattle

Excavation of 400mm – 600mm depth at a distance of 1m from the base of the tree #9 is required to achieve the correct level of the new path which will have an incursion greater than 10% and compromise the structural integrity of the structural root zone.

Tree #9: *Acacia dealbata* – Tree is to be removed as TPZ & SRZ compromised by level of incursion with construction of new path.

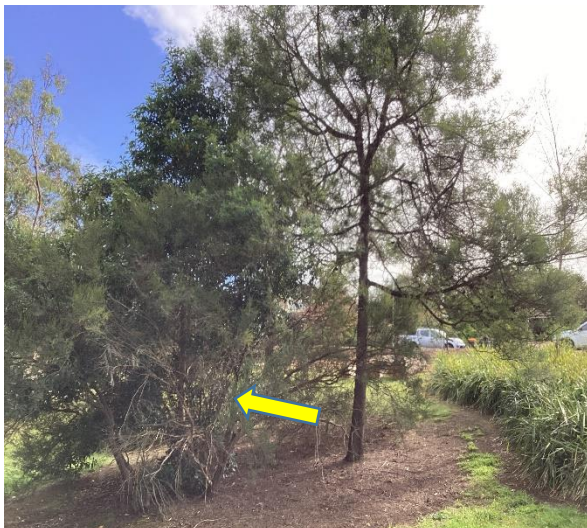
Tree #10 *Leptospermum* sp.

Tree #10: *Leptospermum sp.* - Tree is to be retained. Pruning of lower limb required as indicated in in photo.
