Subject: Talbot Park Landfill Gas and Playgrounds Risk Assessment_Rev2

1 Introduction

City of Monash engaged EHS Support to complete landfill gas monitoring and hand auger investigations in May and August 2022 to assess potential landfill gas risk at proposed playground locations at Talbot Park, Oakleigh South, Victoria.

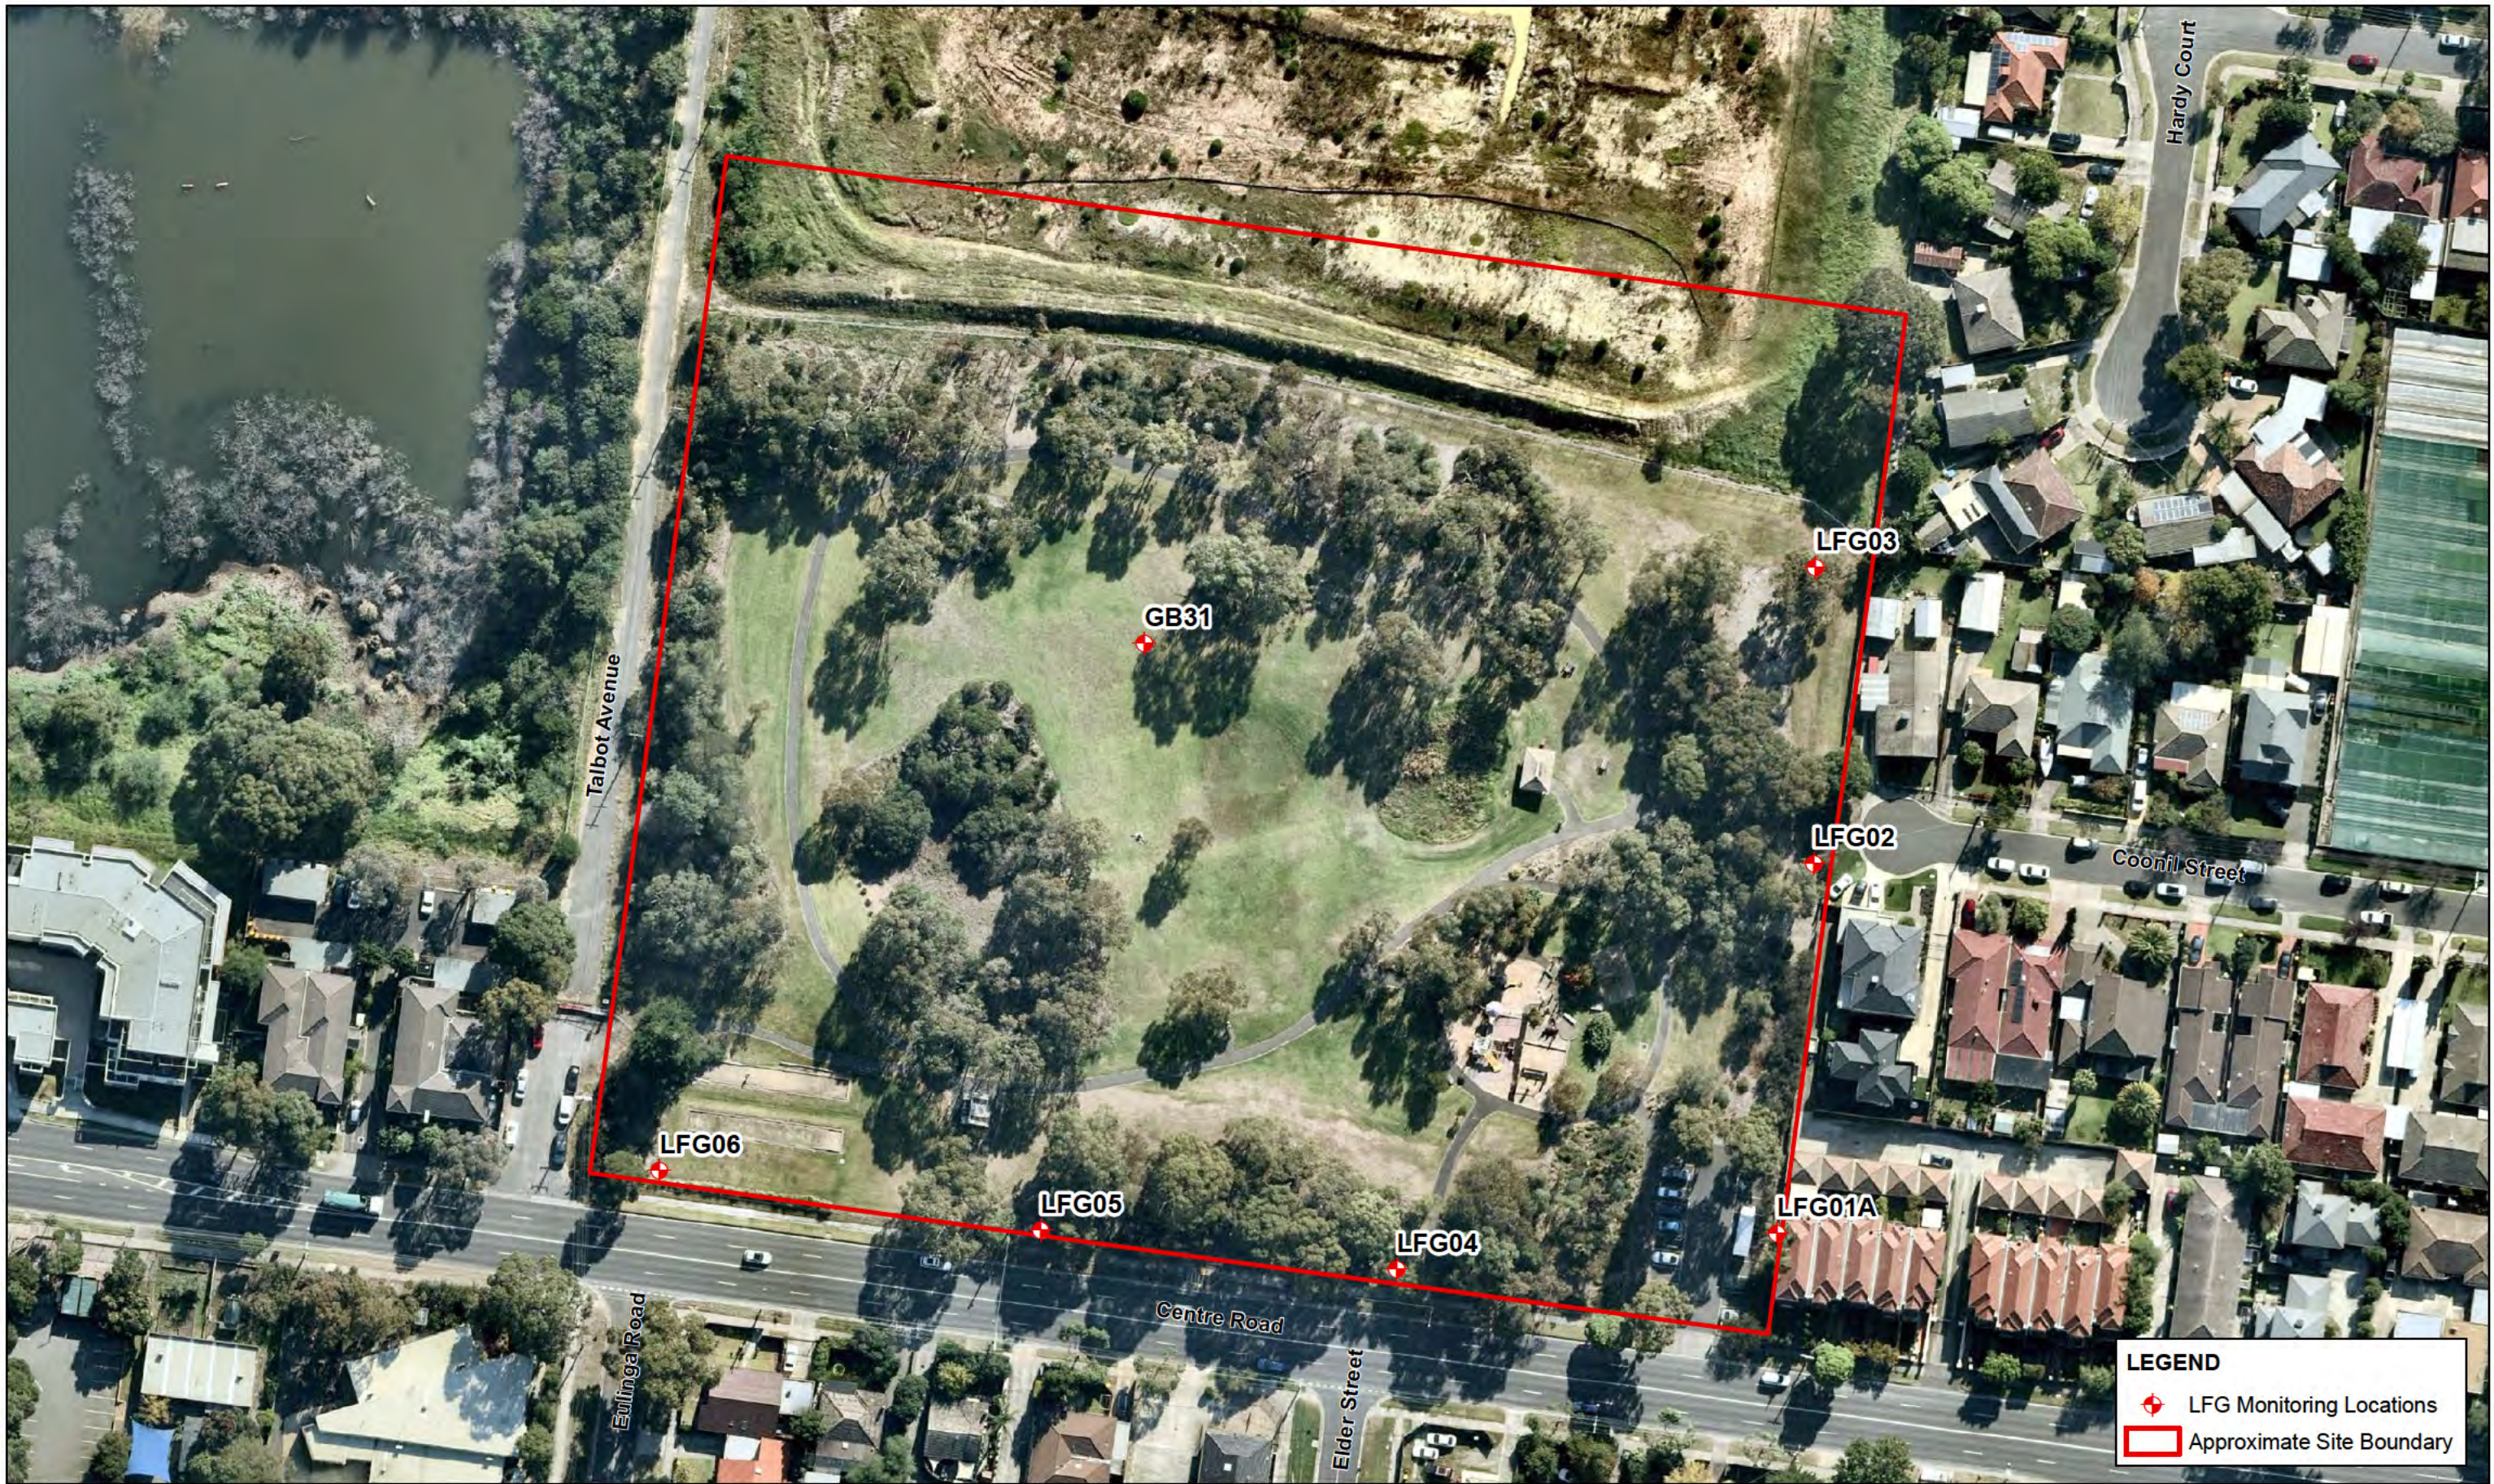
<h3>Site Layout</h3> <div></div> <div></div>	<p>TALBOT PARK CITY OF MONASH</p>		<p>Figure 1</p>

All landfill gas bores to monitor sub-surface landfill gas emissions are shown in **Figure 1**. These were monitored using the GA5000 and results are presented in **Table 2** (below), with exceedances of BPEM action levels indicated in **bold**. Site infrastructure consists of six perimeter landfill gas bores (LFG01a, LFG02 – LFG06 all installed to 6 metres below ground level) and one in waste bore (GB31). Historical results were obtained from previous monitoring events, these are presented along with the May 2022 results in **Attachment A**.

- Methane was recorded below the current BPEM action level of 1% v/v at all locations.
- Carbon dioxide was recorded above the current BPEM action level of 1.5% v/v at all locations except for LFG03.
- The flow rate of landfill gas was noted to be negligible in all of the monitoring bores.

Based on landfill gas bore results – subsurface landfill gas appears to be generally depleted across the site. Flow rates are negligible and there is evidence that oxidation of methane to carbon dioxide is occurring.

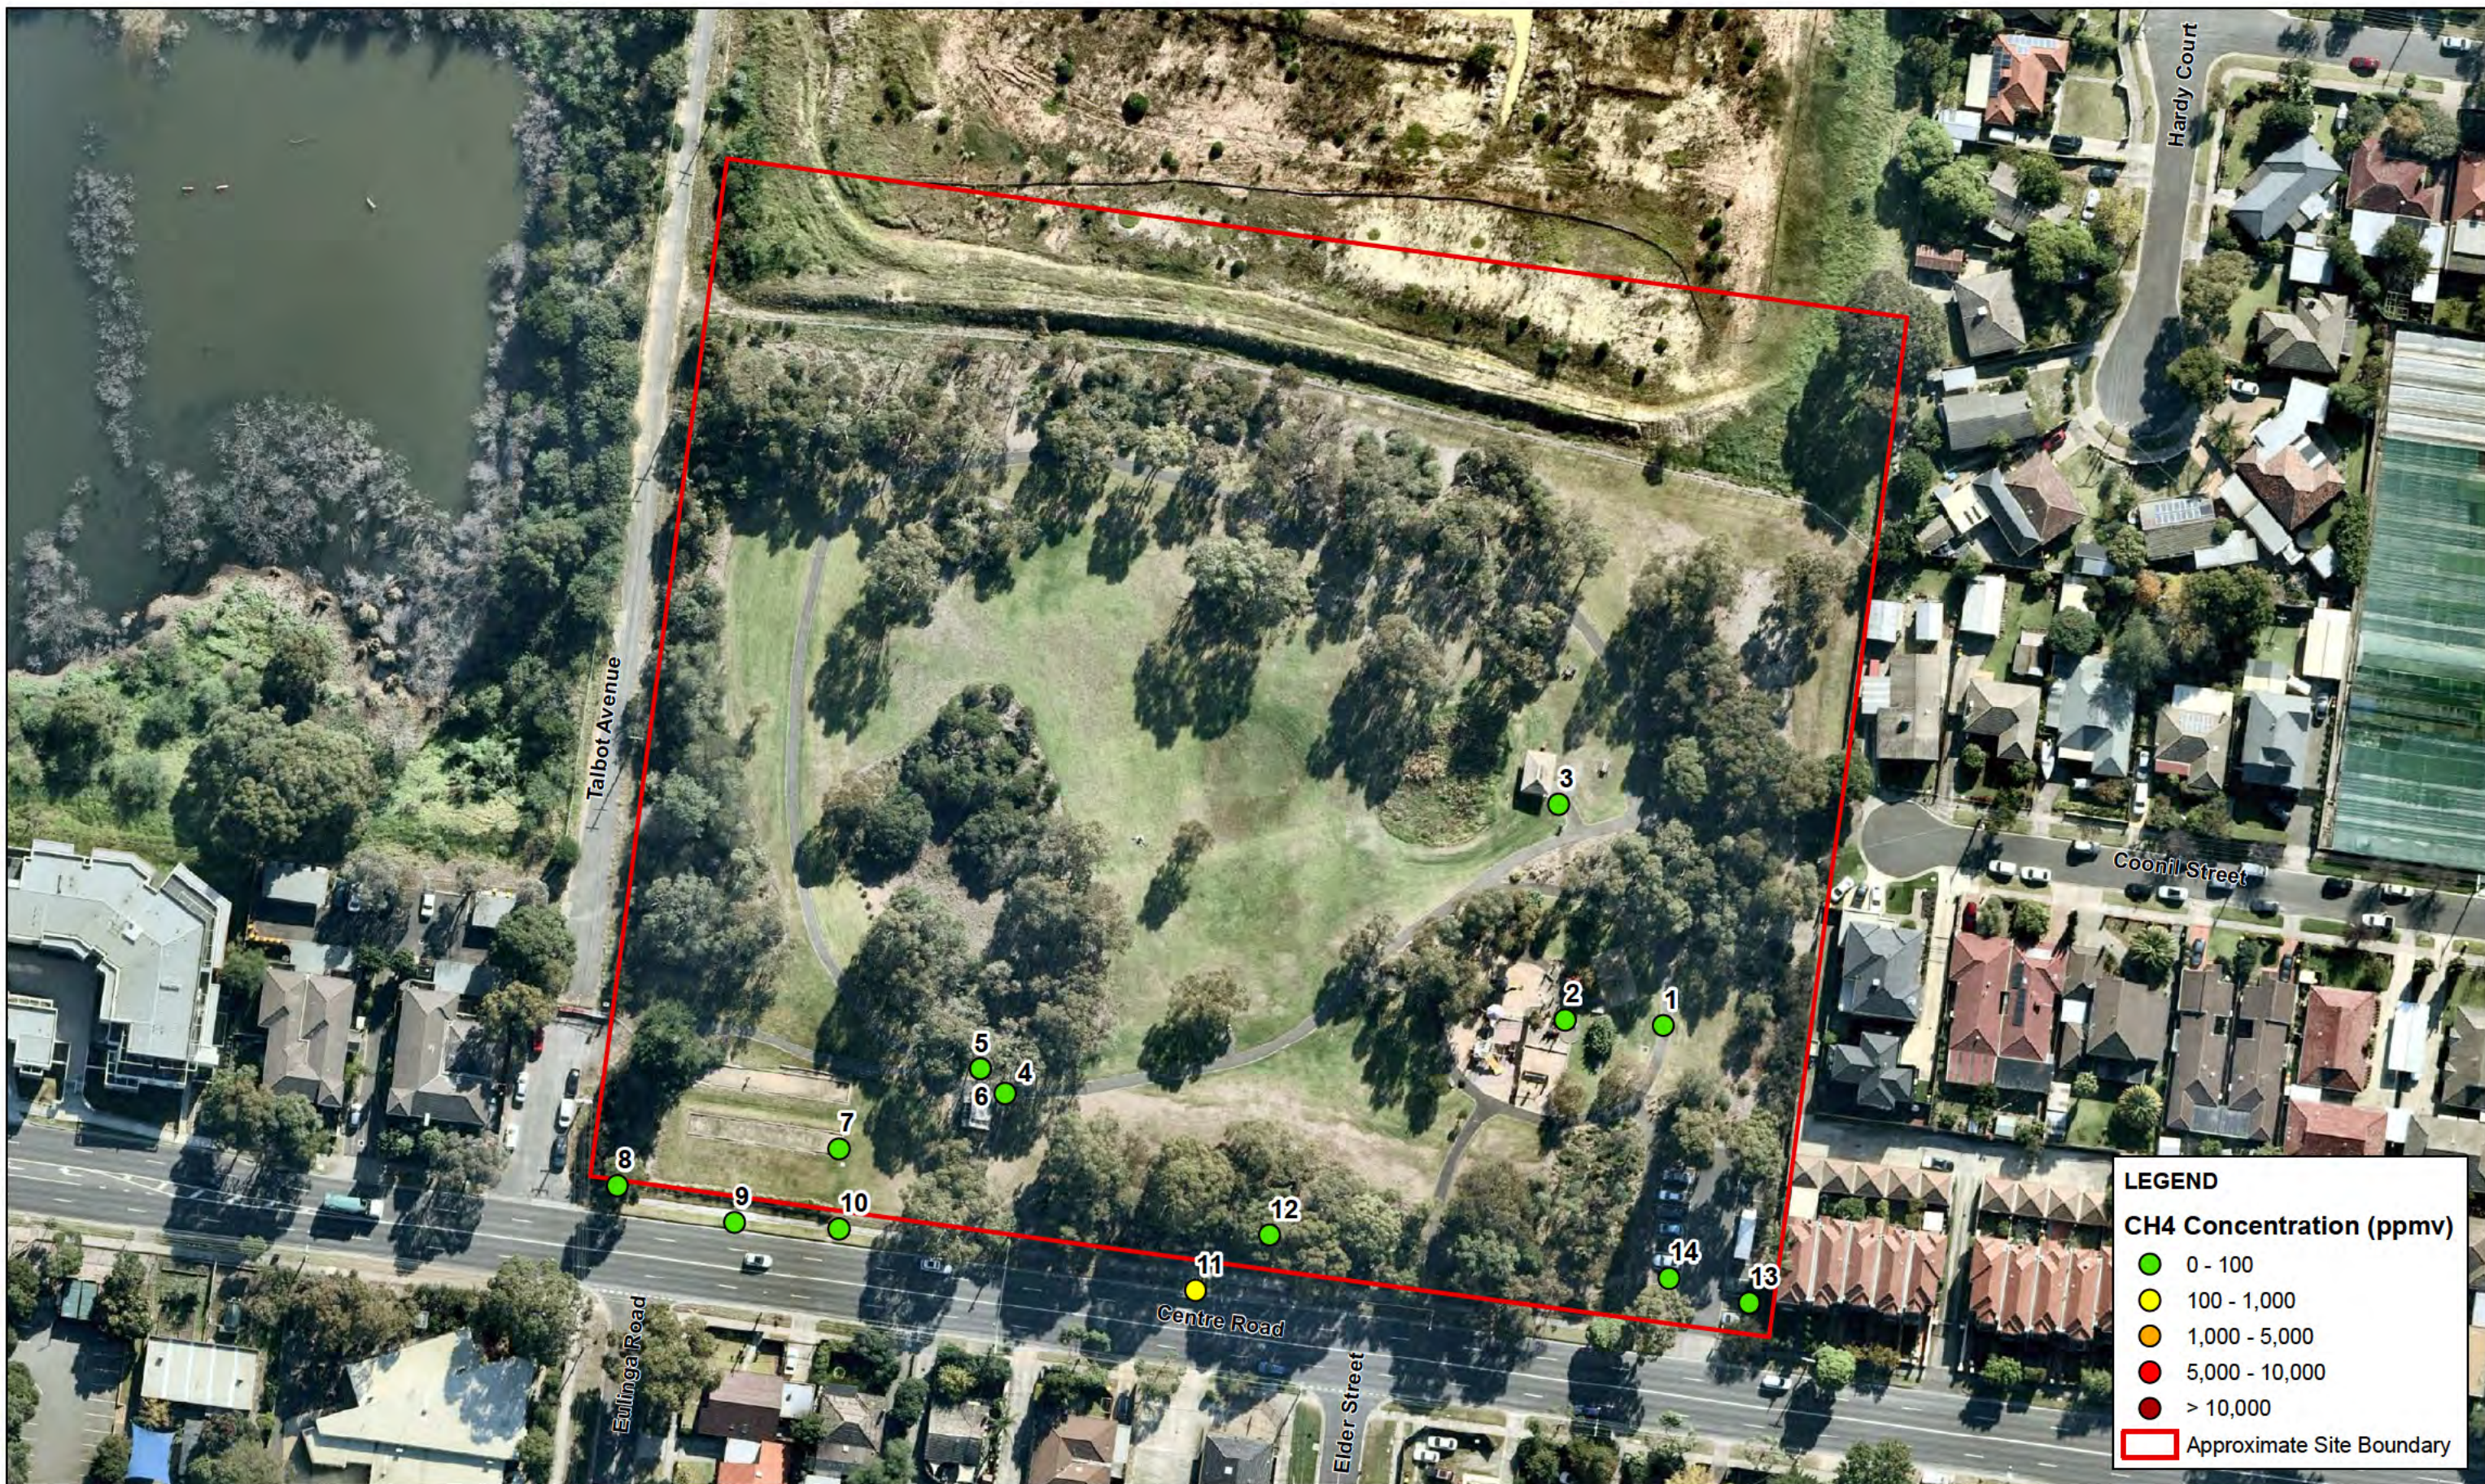
Figure 2

The surface emissions monitoring locations and ranges of recorded methane concentrations are presented in Figure 2. Tabulated results are presented in Attachment A. Field notes and calibration of the equipment used are presented in Attachment B.

- Subsurface Services: a number of onsite stormwater drains and services, and offsite services along Centre Road (to the south).
- Buildings/Structures for LFG monitoring include an onsite playground, toilet block, and barbecue area

All locations monitored were reported below the EPAV Landfill action levels for subsurface services on and adjacent to the landfill site (10,000 ppm or 1% v/v methane) and buildings/structures (5,000 ppm or 0.5% v/v methane). All locations remained similar to ambient conditions except for IDs 7 and 11. These stormwater drains had elevated methane readings at 76.5 and 103 ppmv respectively.

Based on these results, it is not anticipated that landfill gas will occur at elevated concentrations within buildings, structures or services associated with the upgrade of the onsite playground.

Buildings, Structures and Services Monitoring - May 2022

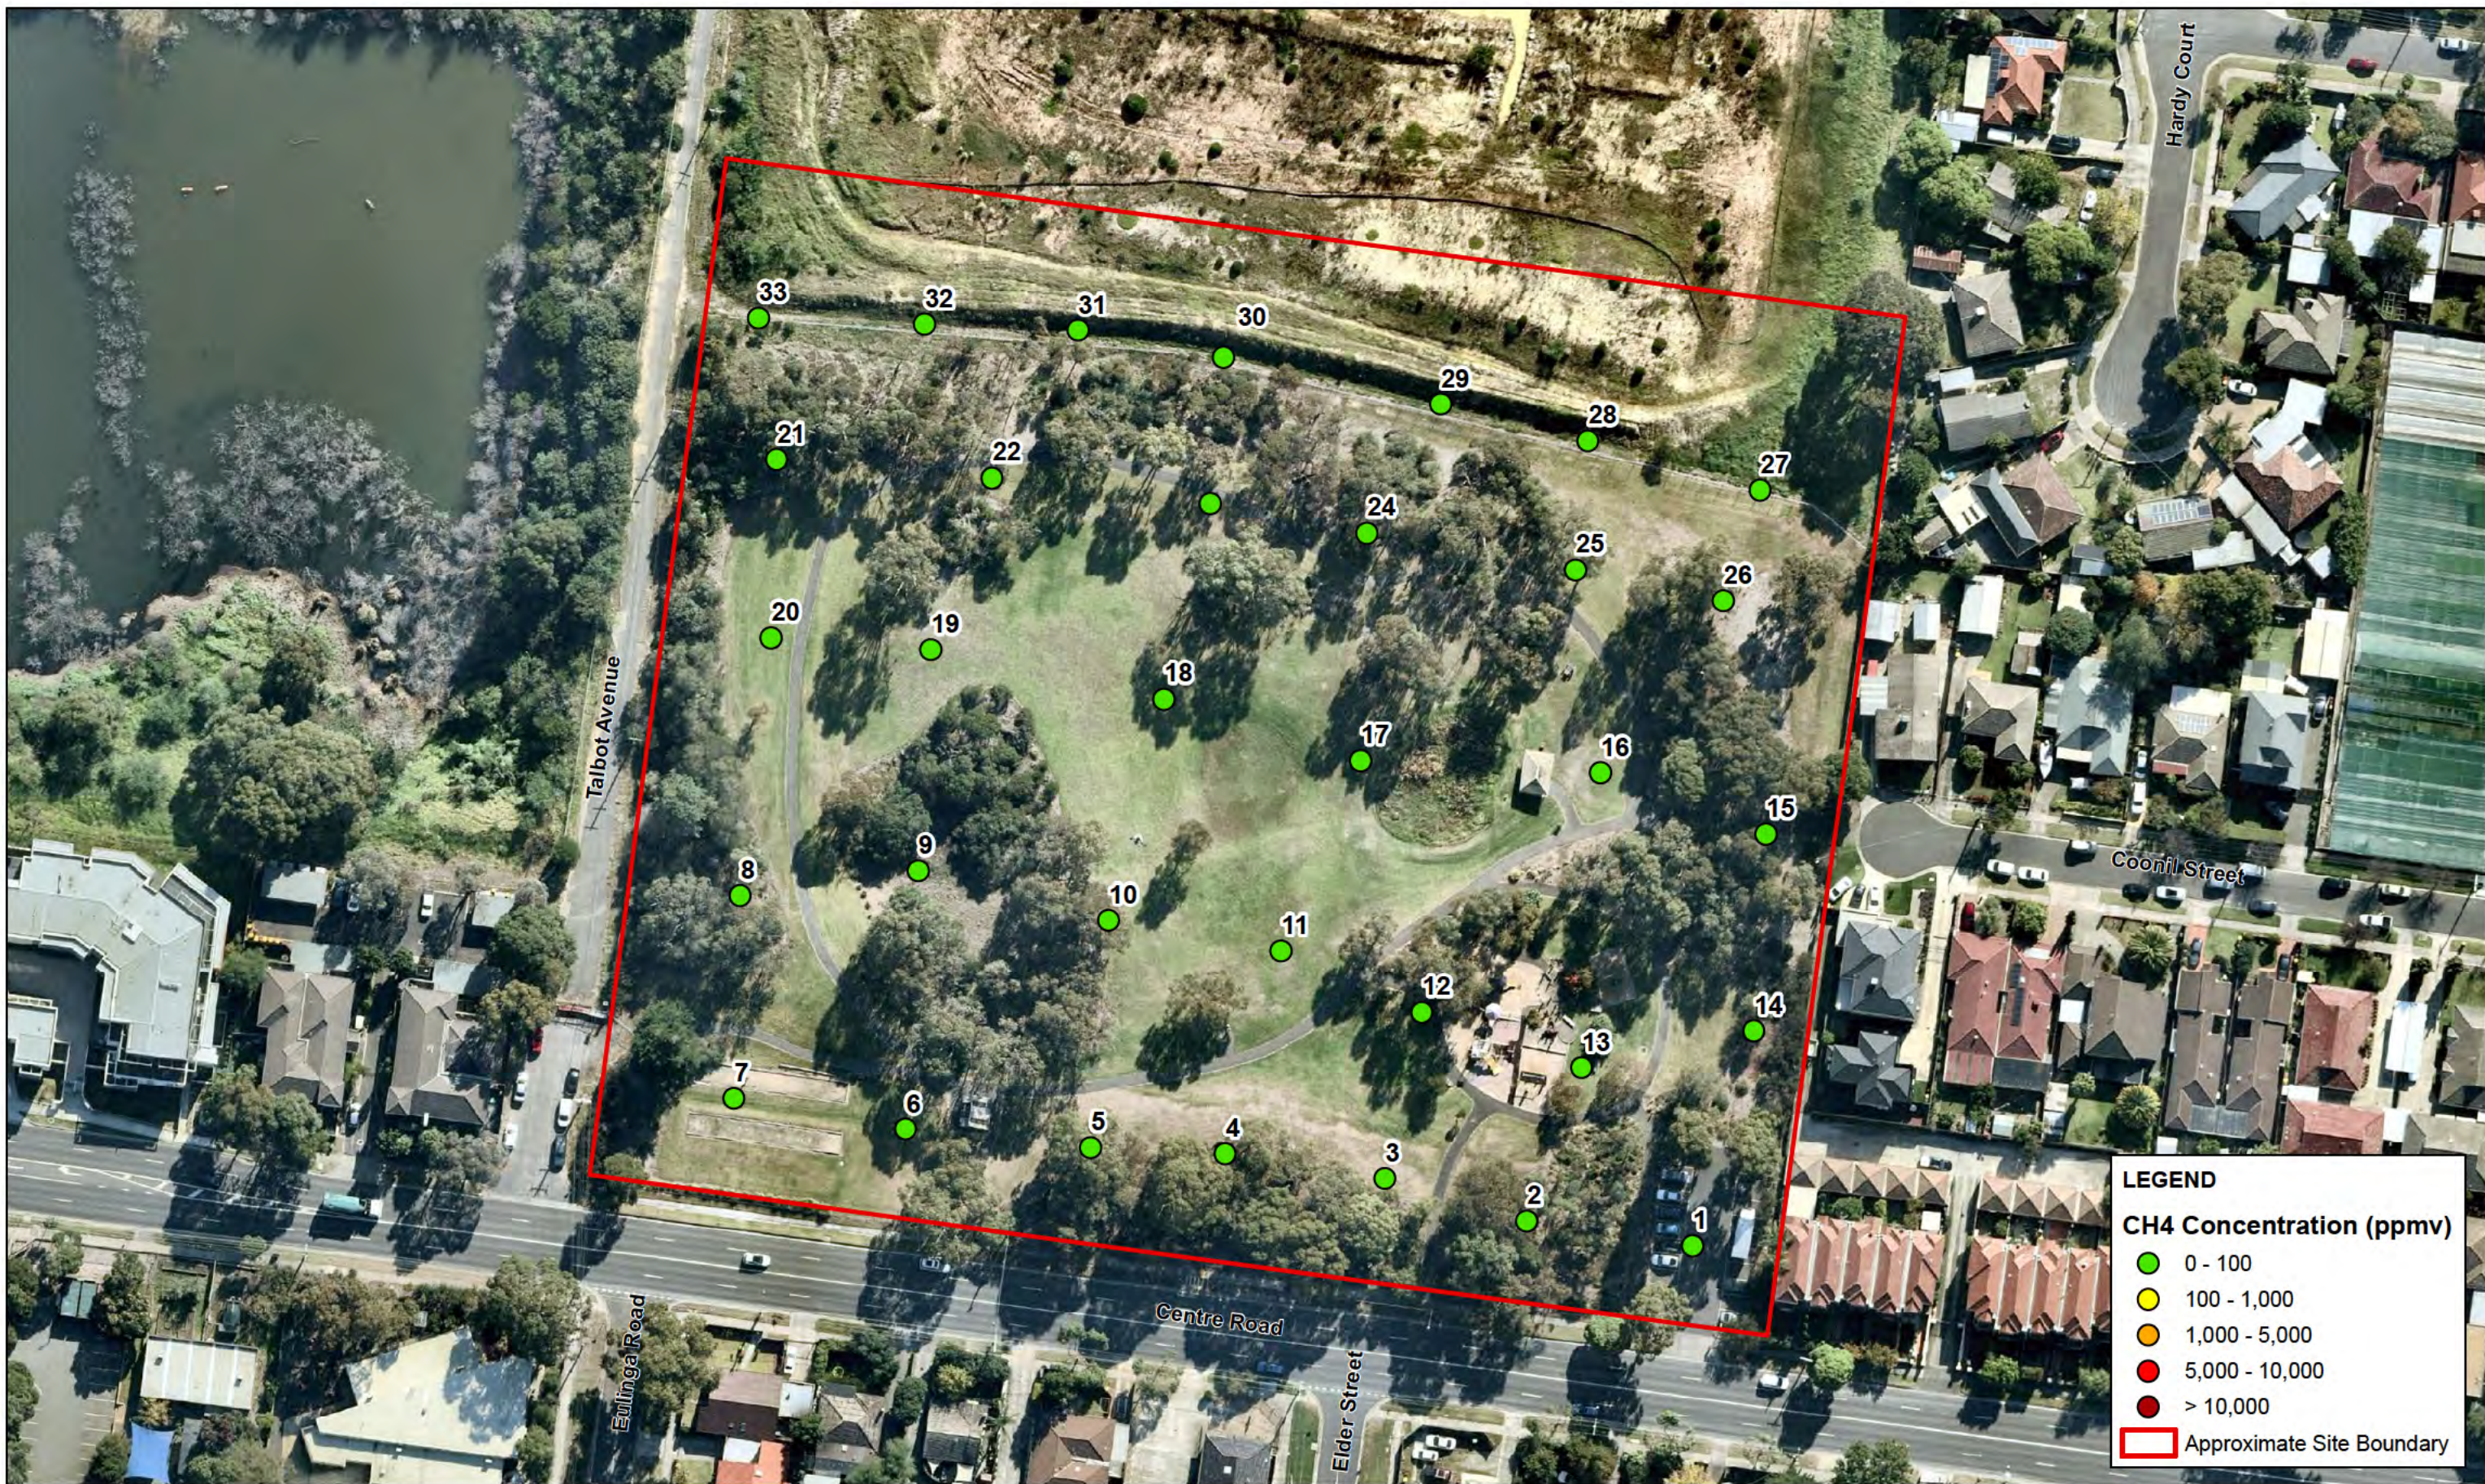
Figure 3

The surface emissions monitoring locations and ranges of recorded methane concentrations are presented in Figure 3. Tabulated results are presented in Attachment A. Field notes and calibration of the equipment used are presented in Attachment B.

The emissions walkover covered a 25m grid across the site, and targeted areas within the site boundary. All locations monitored remained below 2.5 ppmv methane except for Point ID 30, along the northern fence line, which was 10.4 ppmv. The majority of readings were similar to ambient conditions and all fall below the EPAV Landfill gas action levels (100 ppm) for landfill surface final cap levels.

Readings around the vicinity of the current playground and proposed playground extension area (locations 2 – 4 and 11 – 14) remained similar to ambient.

Cap Emissions Walkover - May 2022
